BRIDGE ANALYSIS UNDER EARTHQUAKE MOTION

ABSTRACT

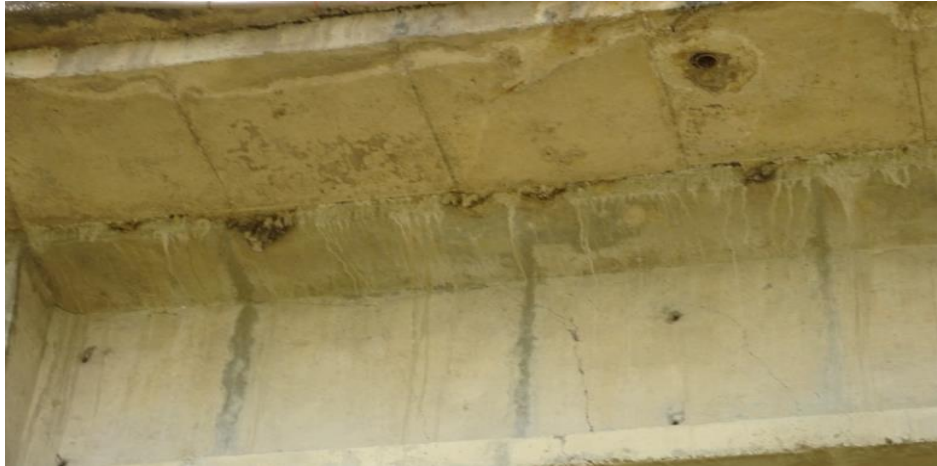
Figure 1. Longitudinal Crack in web of Beam from bottom to top face

Figure depicts longitudinal fracture distribution along the bridge beam and images of seismic damage. The majority of the fractures in the beam's web are angled cracks created as the section ascended from bottom to top. The number of fractures throughout the bridge are almost evenly distributed on the upstream and downstream sides. The closure portion of the construction is where has the most cracks.

They can be found in the middle or end spans of the bridge. The neighbouring parts of the closing section have cracked. The concrete in the mid-span and side-span of the closing portions looked to have collapsed in the area directly beneath the structure's beam.[16] Additionally, concrete extrusion and spalling are evident. Because the pavement was completed before the earth-quake, the fissure on the top of the portion cannot be seen clearly.

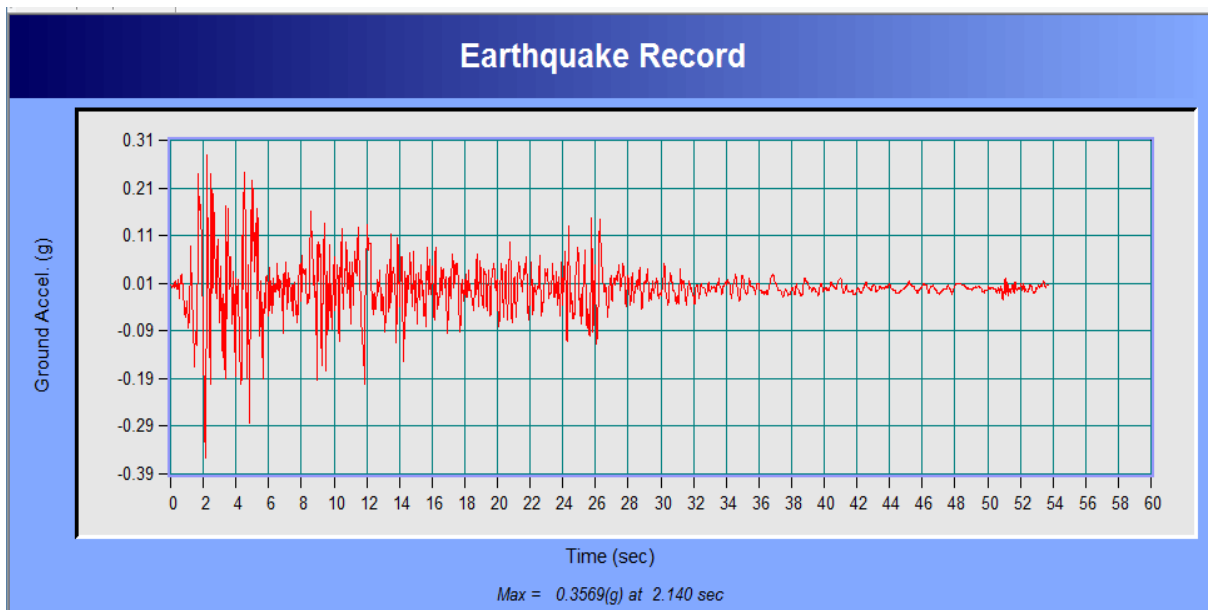
Figure 5: Earthquake Record close to the site

The seismic record and the medium/hard site soil characteristics that are frequently used in the literature for time history analysis are also applicable to the seismic record.

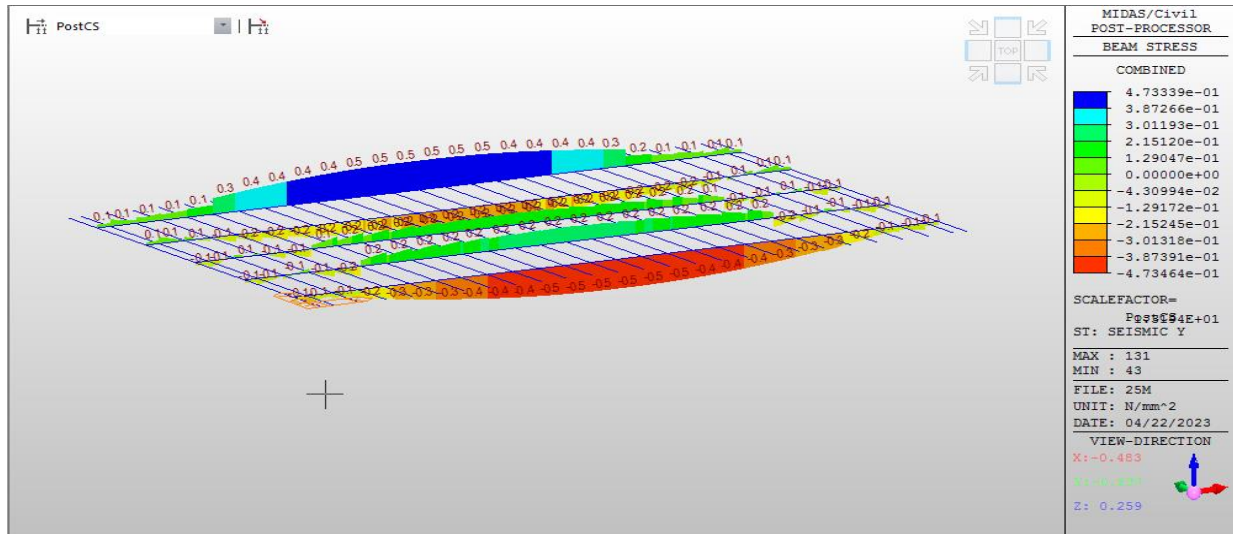
Figure 6: Beam Stress due to earthquake

It should be noted that in scenarios with different input excitations, the cracking damage regions agree with the larger tension and compression stress zones. The initial force of the dead load under the ground movements is taken while doing time-history analysis for the bridge. Because of short period of study, just the beam's stress responses under scaled-amplitude ground motions are described. The major compressive stress of M45 concrete's axial compressive strength (40.5 MPa). The major tensile and compressive stress values of the webs are quite low for side-spans. The principal stresses' maximum values are 43 MPa for tensile stress and 131 MPa for compressive stress.

The high tensile and high compressive stress distribution regions that are determined from numerical computation are closer to the real fracture zones. The results are in line with the Bridge's seismic damage. The major determinant of the stress on the bridge's main beams is the height of the piers, with the span perhaps having a secondary effect. The bridge's spans are longer, and its principal tensile and compressive stresses are higher. It demonstrates how broadly applicable the analytical findings of this paper are.

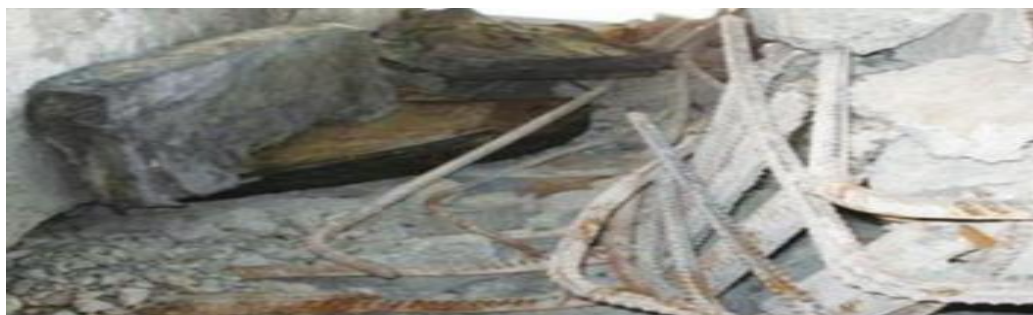
Figure 7: Damaged Bearing

The seismic cracks at the ends of the beams for the bridge's two side spans is depicted in The evolution of seismic cracks can be inferred from the look. The end of span is vulnerable to significant movement caused by opposite ground movement when the side span's span is considerable. Damage to the bearings and contact of the beam end with the shear keys will result. Because there is no lateral constraint at the end of the beam once the shear keys fail, the displacement reaction will be larger.

The bearings will rapidly wear out their vertical tensile limit and convert to compression-only bearings if the end span mass to middle span mass ratio is low or there is significant vertical earthquake activity. In meantime, it is simple to slap the top of the pier vertically with beam beam.

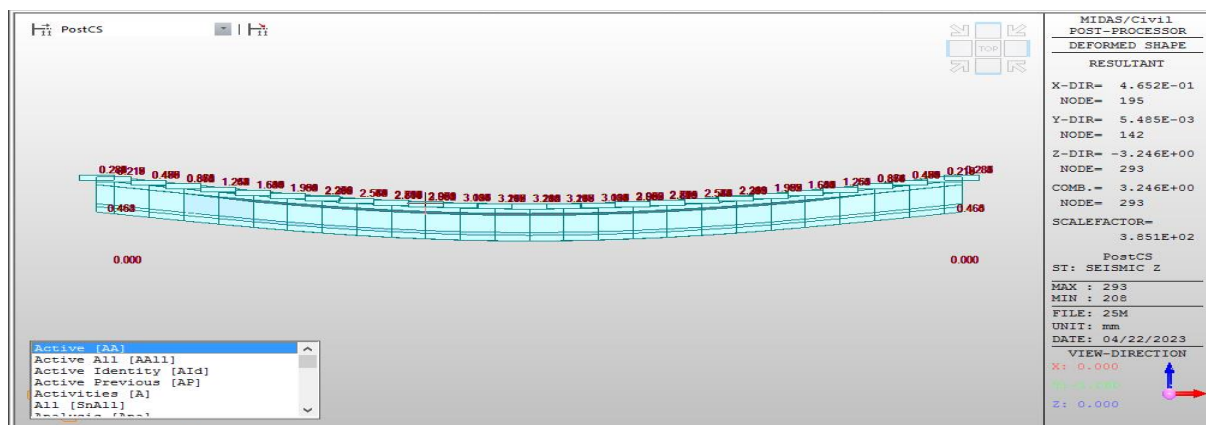
Figure 8: Beam Deformation due to shear

The lateral displacements of the Bridge's spans that were still there after the earthquake were clearly visible. The beam's lateral displacement was 29 cm.

The beam transverse drift reactions computation model. side span of the beam ends exhibit significant lateral displacements following damage to the shear keys. the beam ground movements' maximum transverse displacement response. The beam ends' transverse displacement reactions to ground movement are somewhat bigger (29 cm) than the remaining displacement after the earthquake.
