LANDSLIDE EROSION ALONG THE RACH TRA RIVER, HO CHI MINH CITY, VIETNAM: THE CURRENT SITUATION AND PROPOSED SOLUTIONS

II. THE SITUATION OF LANDSLIDE EROSION ALONG RACH TRA

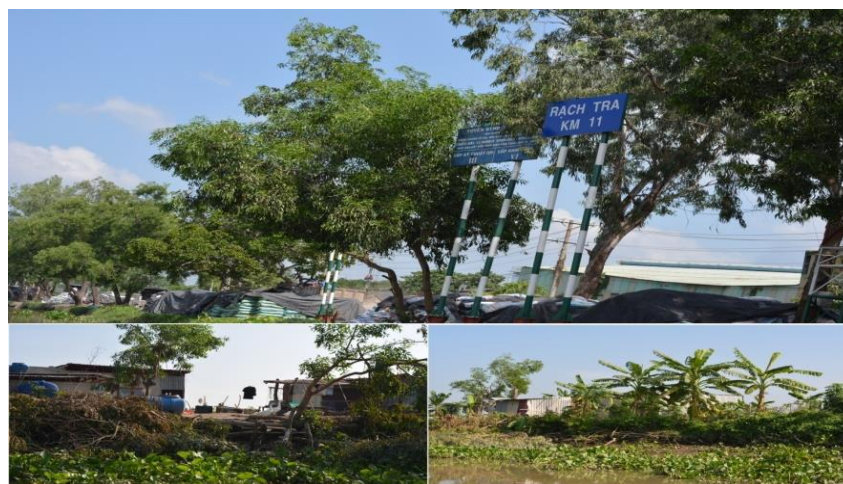
People's activities to cut down wild plants to get land to build houses, warehouses and set up wharves close to the shore, this not only destroyed the riverine ecosystem but also increased the burden of the ground. Thereby, creating pressure, causing subsidence and destabilization of the riverbank, leading to the risk of landslide.

Figure 1. The warehouses and buildings built along Rach Tra

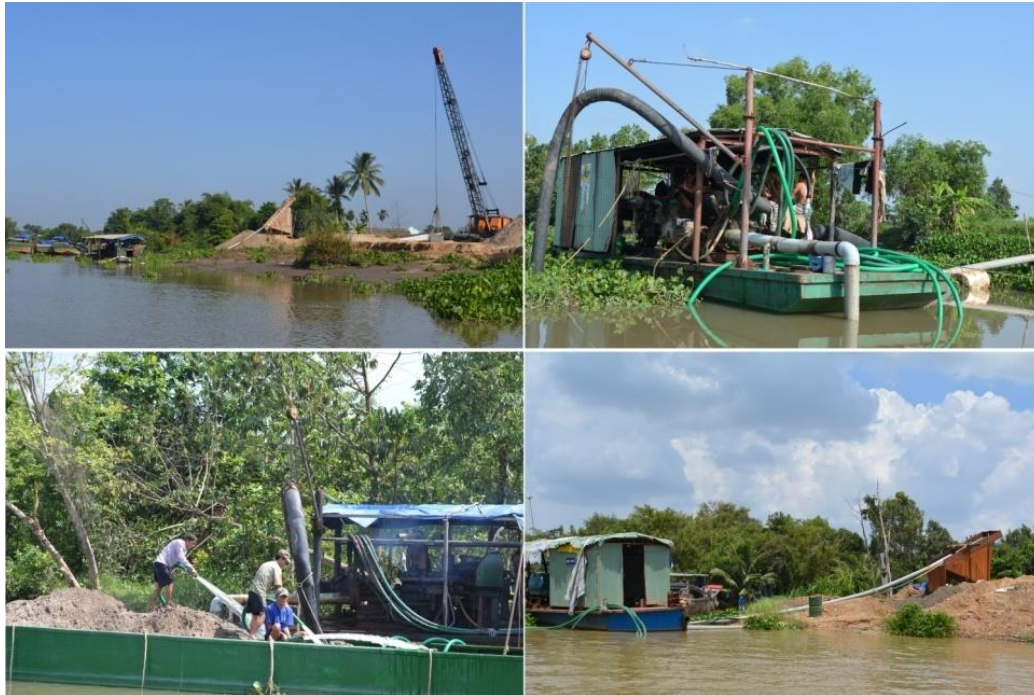
Besides, illegal sand mining on the river, especially the situation of digging and sucking deep into the river bed to get sand, caused landslides at the place of digging and sucking sand, as well as changed the flow, causing abnormal landslides, even in places where protection embankments were built.

Figure 2. Illegal sand mining in Rach Tra

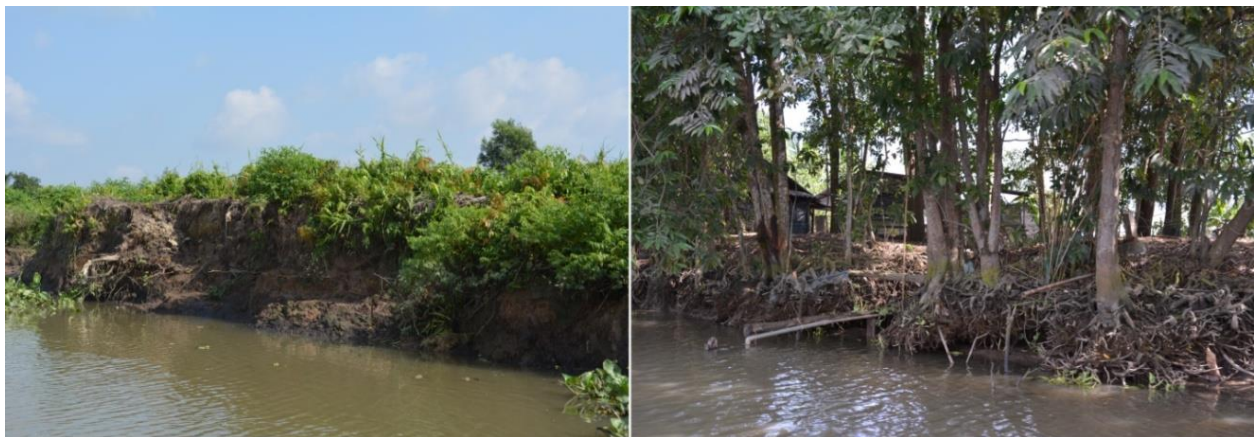
We have investigated that, every day in Rach Tra, there were an average of 5-6 boats and ships working as sand shovels, operating continuously and publicly. The ships, boats and barges carrying sand regularly on the river have created strong waves hitting the shore, this caused the existence of clefts along the land bank and increased the risk of landslides.

Figure 3. Vegetation destroyed by riverbank erosion

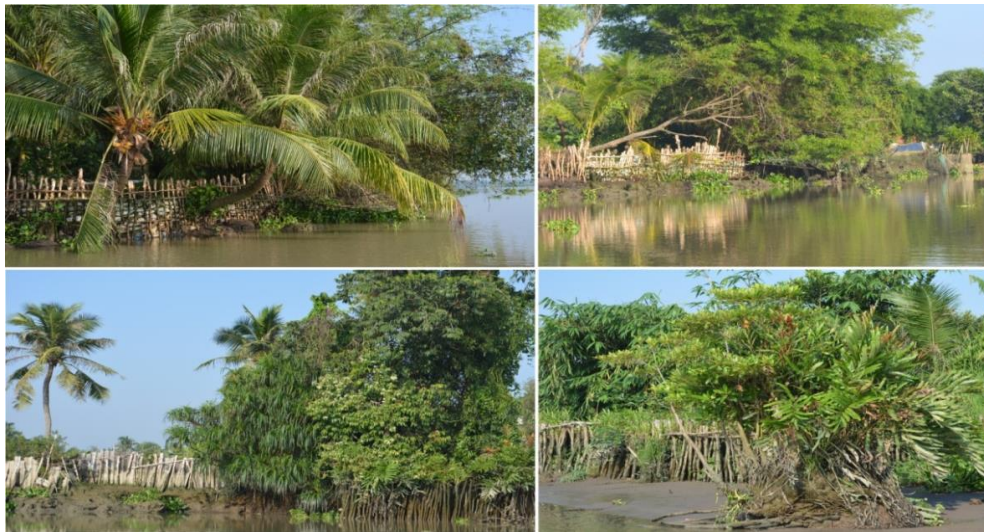
Figure 4. The anti-erosion works along Rach Tra

- Build constructions to block the waves washing ashore created by moving boats [3], [4].
- Prevent river bank erosion by planting trees to keep the soil near the riverbank [5].
- Post warning signs in landslide-prone areas [6].
- Strictly control sand mining activities on the river [7], [8]. Overcome the imbalance of mud and sand to limit the risk of landslides, besides completely prevent illegal sand mining [9].
- Paying attention to the propaganda and dissemination of the law, raising people's awareness about riverbank erosion prevention [10].
- Fabricate a monitoring system to monitor river bank erosion [11], [12], etc.
