ANALYSIS OF PISTON FAILURE: A REVIEW

ABSTRACT

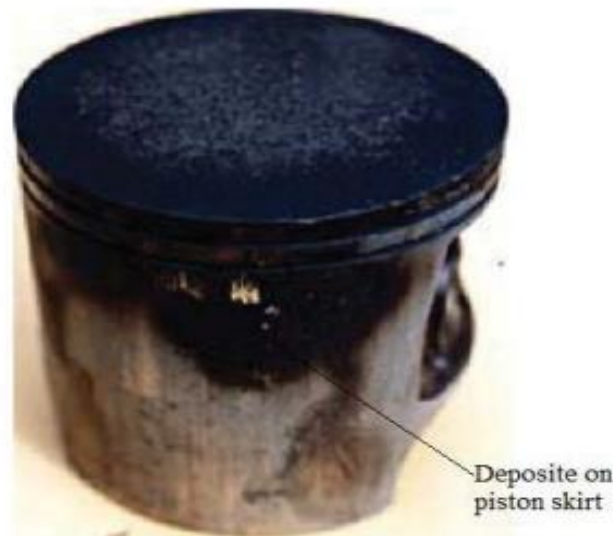
Figure 4. Piston skirt shows deposition [2]

typically fail in a variety of ways, including carbon deposits, ash deposits, debris marks, chipping, etc. Figure4 shows the piston skirt deposition. These problems occur when the piston gets too hot and experiences increased temperature and pressure. Mechanical fatigue is the term used to describe when the shape of the piston changes or deforms. Cracks or fractures result from fatigue. Before the piston fails it exhibits any early signs. We must accurately maintain the piston and provide it with sufficient lubrication and a better cooling system in order to prevent these problems.

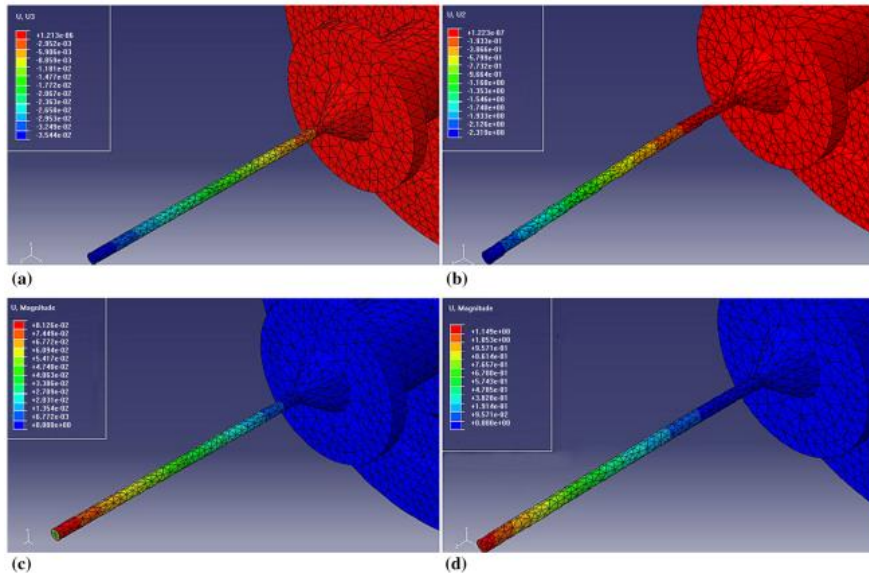
Figure 5. Deflection of the piston under (a) compression, (b) bending, (c) torsion, (d) combined bending/torsion loadings [4]

Ali Mamedov. et. al., [4] Review the failure analysis of the piston from the primary standard pressure unit. The piston already has the fracture. An EDX spectrometer was used to analyse the material, and a scanning electron microscope was used to look at the fracture surfaces. According to the findings, the piston's substance is only capable of bearing compression load. But even when the piston experiences only minor bending and torsion, or torsion and bending combined, the fracture was brought on by external torsion loadings as shown in figure5. In its usual operation condition, the piston is safe for compression loading. The piston has failed when it is subjected to any form of force, including bending and torsion. All that is compressive about the material utilized in the piston is that. The term "EDX spectrometry" refers to the chemical characterization of a trial and energy dispersive x-ray element analysis.

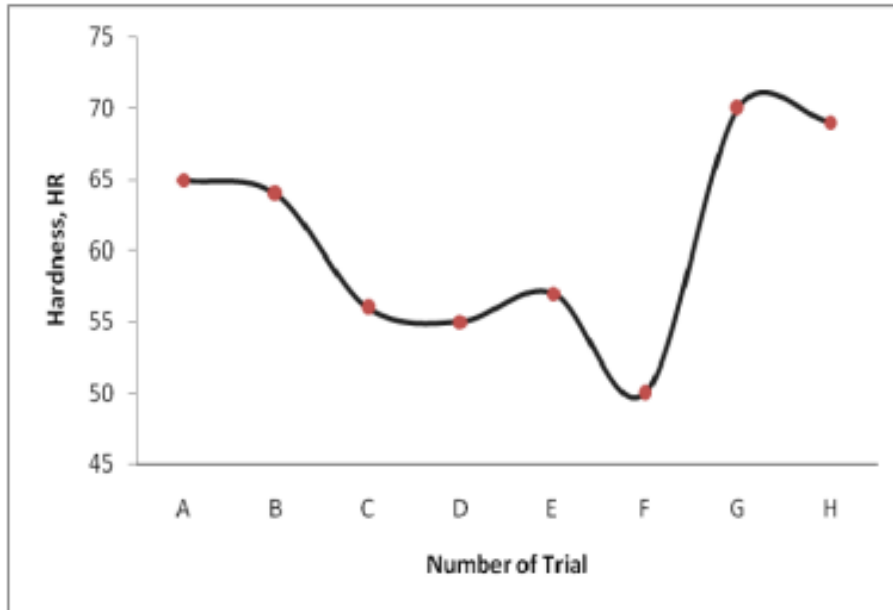
Figure 8. Hardness values for various locations [7]

Venkatachalam, et. al., [7] studied the experimental investigation of diesel engine piston. In this paper the failures of the diesel engine piston are analysed by using different experimental methods. The piston's typical value is 61 HRB (hardness Rockwell in B scale) can be observed in figure 8. The piston is made of aluminium alloys. A high silicon content lengthens the life of the piston, but silicon cannot bear up high temperatures. The microstructure of an alloy mostly determines its strength and hardness. For pistons, aluminium alloys are outstanding. However, there are also some downsides, which include failure-causing issues like cracks in the piston cylinder and erosion on the piston head from wear. Experimental techniques included visual inspection to locate the failure zone and identify marks on the piston, chemical analysis to determine the materials' composition, a hardness test to determine the material's hardness, and optical inspection to determine the microstructure—the microstructure being crucial to the piston's long life. Finally, scanning electron microscopy (SEM) was observed in figure 9 was used to see where the piston had failed.

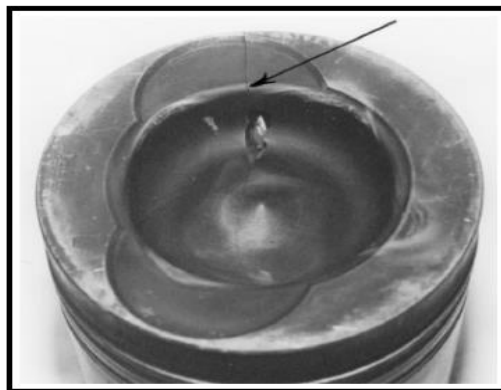
Figure 18. Looking down the hole formed from the combustion chamber to the lower ring.

The cracks initiated at the edge [17]

Matrin et. al.,[17] was made research on the piston after 1276 hours of operation, a diesel engine that had failed in service was used for study in an effort to identify the cause of the failure and depicts the failed piston shows in figure18, which may have a crack that extends from the crown to the top of the gudgeon pin hole. Failure of the piston was caused by a high-porosity location at the upper edge of the combustion chamber bowl where a fatigue fracture growth process began. This is an uncommon location for the start of a crack; typically, it starts at the gudgeon pin hole and progresses to the piston's crown. This region must have experienced stresses that were far higher than would have been predicted, and the only way this could have happened is if the fuel had too early exploded or burned. The crown and skirt both tested at 67 HV20 and 98.5 HV20, respectively, for hardness. It revealed that the piston crown had weakened as a result of contact to the combustion gases, but there was no sign that excessive heat growth had caused any harm.

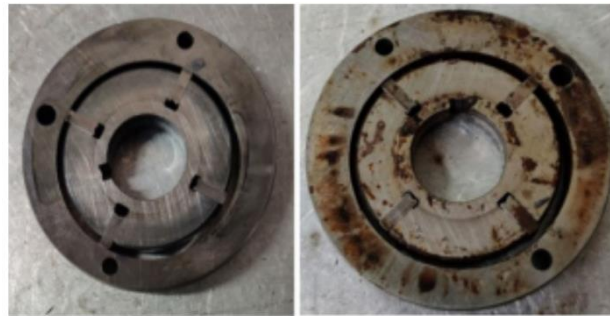
Figure 19. Original and failed veins of supply pump [19]

Vikas Deulgaonkaret.al., [19] The existing project examines the timing device piston and vanes failure in the supply pump of a gasoline pump system used in transport utility vehicles. Investigations are conducted to assess the timing device piston and supply pump failure in transport utility vehicles. On the surface of a failed timing device piston, cracks are visible. Figure 19 shows that the original and failed veins. The crack development is recognized to a lack of fuel, which causes dry running and increases friction. The failure of the piston in the timing device is also influenced by the presence of fuel contaminants. The primary factor behind supply pump failure and vane failure has been determined to be increased friction between the rotor and vane housing (i.e., vane housing). Vane failures have an impact on the engine's efficiency and result in partial fuel combustion. Dry pump operation and surface rusts brought on by water presence are reasons for the vane failure. The failed apparatus has undergone scanning electron microscopy and energy-dispersive spectroscopy. The current work has provided corrective measures to stop the failure of the supply pump's piston and vanes and the timing device.
